REAR COMBINATION LAMP ASSY LH REPLACEMENT

650HC-01

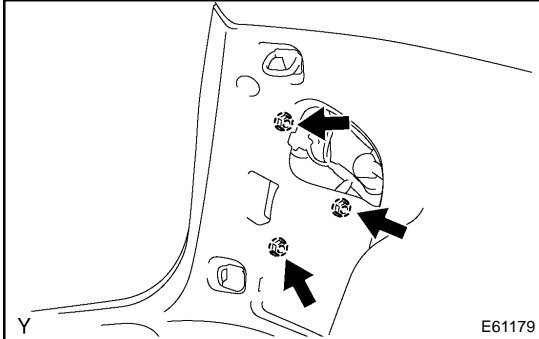
- (a) Remove the service hole cover LH.
- (b) Disconnect the connector and remove the 3 nuts.

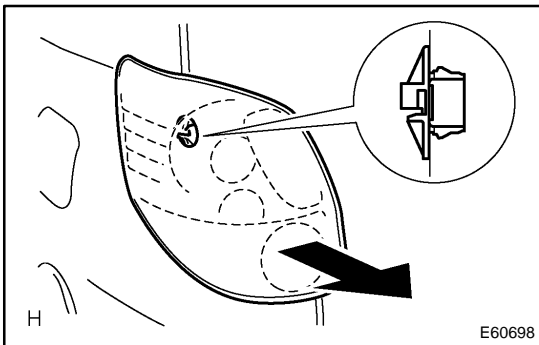
- (c) Pull out the rear combination light assy LH to the back of the vehicle, and remove.
