INSPECTION

700HK-01

2003 COROLLA MATRIX (RM940U)

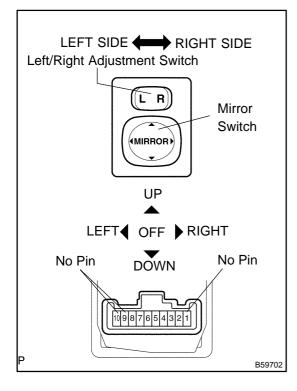
1. INSPECT OUTER MIRROR SWITCH ASSY

(a) Left side for left/right adjustment switch: Inspect the mirror switch continuity.Standard (Left side):

Terminal No.	Switch position	Specified condition
_	OFF	No continuity
4 ⇔ 8 6 ⇔ 7	UP	Continuity
4 ⇔ 7 6 ⇔ 8	DOWN	Continuity
5 ⇔ 8 6 ⇔ 7	LEFT	Continuity
5 ⇔ 7 6 ⇔ 8	RIGHT	Continuity

(b) Right side for left/right adjustment switch: Inspect the mirror switch continuity.

Terminal No.	Switch position	Specified condition
_	OFF	No continuity
3 ⇔ 8 6 ⇔ 7	UP	Continuity
3 ⇔ 7 6 ⇔ 8	DOWN	Continuity
2 ⇔ 8 6 ⇔ 7	LEFT	Continuity
2 ⇔ 7 6 ⇔ 8	RIGHT	Continuity

If the result is not as specified, replace the switch assembly.

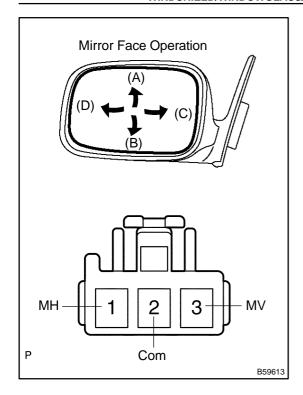
2. INSPECT OUTER REAR VIEW MIRROR ASSY LH

- (a) Disconnect the outer rear view mirror assembly LH connector.
- (b) Apply battery voltage and inspect the mirror motor face operation, as shown in the table and illustration.Standard (LH):

Battery connection	Mirror position
Positive (+) ⇔ MV (3) Negative (–) ⇔ Com (2)	Turn upward (A)
Positive (+) \Leftrightarrow Com (2) Negative (-) \Leftrightarrow MV (3)	Turn downward (B)
Positive (+) ⇔ Com (2) Negative (-) ⇔ MH (1)	Turn left (C)
Positive (+) ⇔ MH (1) Negative (–) ⇔ Com (2)	Turn right (D)

If the result is not as specified, replace the mirror assembly.

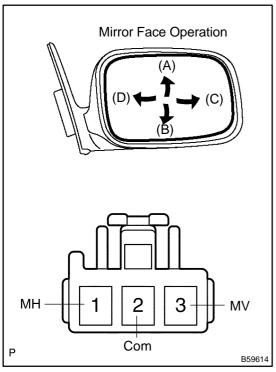
3. INSPECT OUTER REAR VIEW MIRROR ASSY RH

- (a) Disconnect the outer rear view mirror assembly RH connector.
- (b) Apply battery voltage and inspect the mirror motor face operation, as shown in the table and illustration.Standard (RH):

Battery connection	Mirror position
Positive (+) ⇔ MV (3) Negative (−) ⇔ Com (2)	Turn upward (A)
Positive (+) \Leftrightarrow Com (2) Negative (-) \Leftrightarrow MV (5)	Turn downward (B)
Positive (+) \Leftrightarrow Com (2) Negative (-) \Leftrightarrow MH (1)	Turn right (D)
Positive (+) \Leftrightarrow MH (1) Negative (-) \Leftrightarrow Com (2)	Turn left (C)

If the result is not as specified, replace the mirror assembly.
